Riparian restoration of lowland streams in the Southern Murray- Darling Basin

Monash University, School of Biological Sciences & Murray- Darling Basin Authority

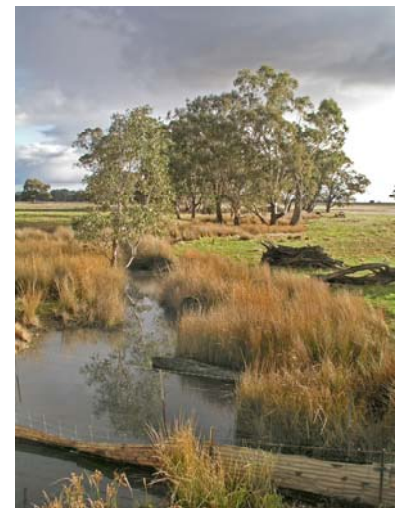
***Faithful Creek, Victoria.
A degraded zone, typical of
small creeks throughout
southeastern Australia***

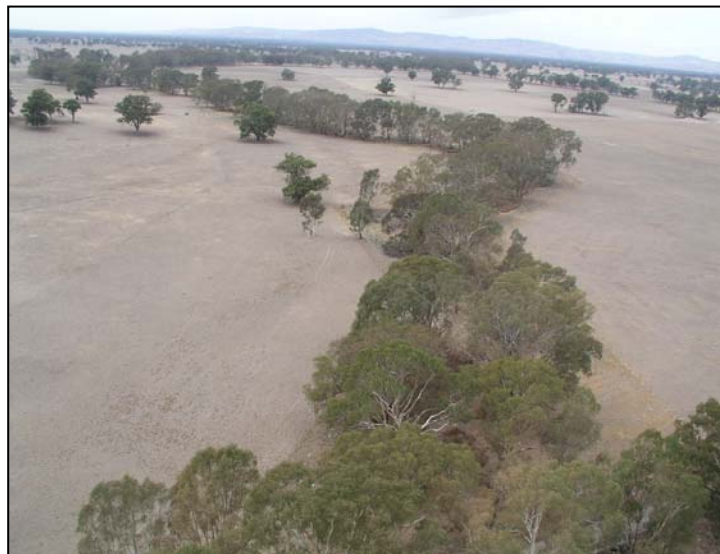
Aerial view of Faithfuls Creek, Victoria showing the extent of clearing

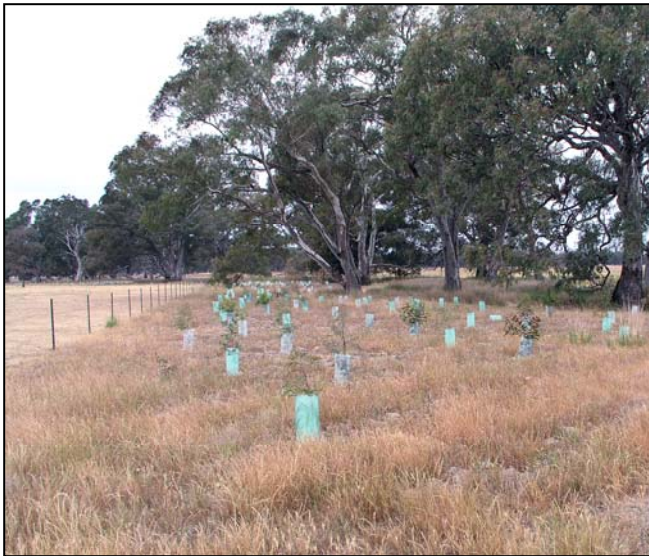
Faithful Creek treatment site in November 2006 just after planting.

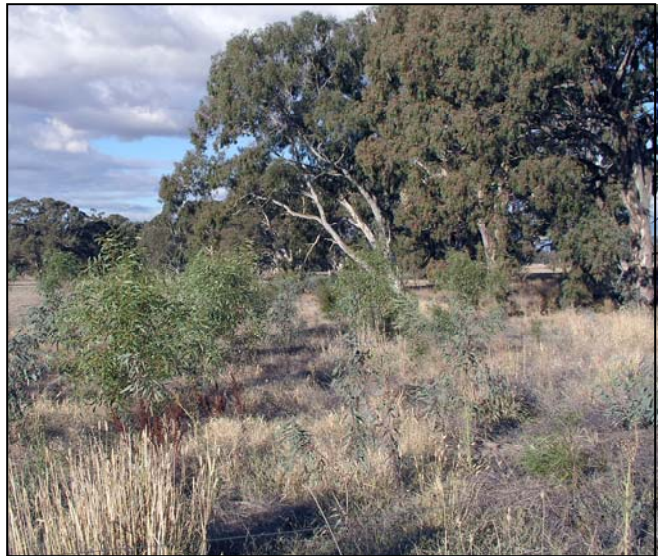
Faithful Creek treatment site in April 2008 showing vegetation establishment

natural regeneration of the dominant tree River Red Gum at fenced sites has been marked, with densities of up to 14 400 seedlings /ha along Faithful Creek. An examination of the soil seed bank at a subset of sites representing a range of riparian conditions showed that exotic weeds dominated and most pre-european taxa were absent. A steady decline in the abundance and diversity of macrophytes and aquatic fauna at our sites has been evident due to drought conditions. Data collected to benchmark pre-restoration conditions across all sites have revealed some clear relationships between aspects of riparian condition and some key response variables. For example, riparian canopy cover greater than ~50% is required before leaf litter consistently accumulates in the stream channel. This litter has subsequently been shown to form the major resource base structuring aquatic food webs in these systems.
