# *Sand slugs and fish movement in the Murrumbidgee River: can you restore and maintain deepwater habitats in sediment-impacted large rivers?*

## *Abstract*

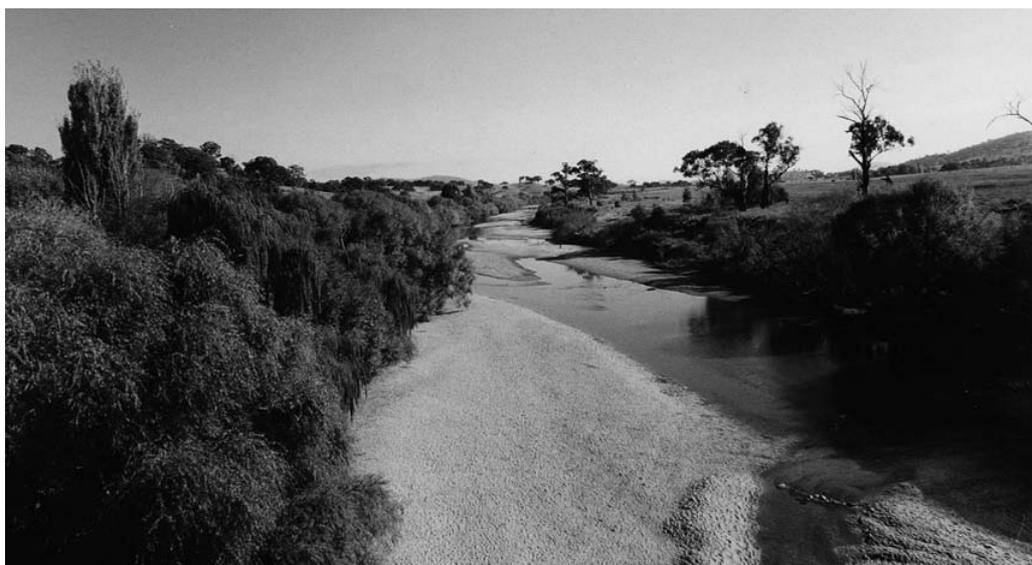
*Figure 1. The sand impacted area as viewed downstream from Tharwa Bridge*

A section of the Murrumbidgee River in the Australian Capital Territory (ACT) below Tharwa has been severely impacted by habitat degradation, mainly the accumulation of sediments (sand). There is little habitat diversity remaining as the river has changed from a narrow, self-scouring channel to a wide depositional system (**Figure 1**).

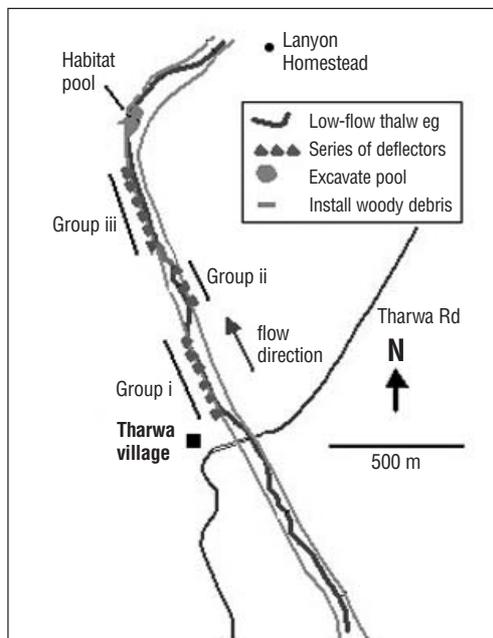
Figure 3. Diagram showing location of the low-flow thalweg, deflectors and habitat pool in the Murrumbidgee River, ACT

The deflectors were constructed in three groups (Figure 3):

- i. On the left bank starting 150 m below the bridge, extending for 300 m. Six deflectors were required in this section.
- ii. On the right bank starting 550 m below the bridge, extending for 150 m. Three deflectors were required in this section.
- iii. On the left bank starting 740 m below the bridge, extending for 320 m. Six deflectors were required in this section.

The grouping of the deflectors was dictated by the position of the low-flow thalweg which crossed from the left bank to the right bank for a distance of 150 m before crossing back to the left bank again (Figure 3).

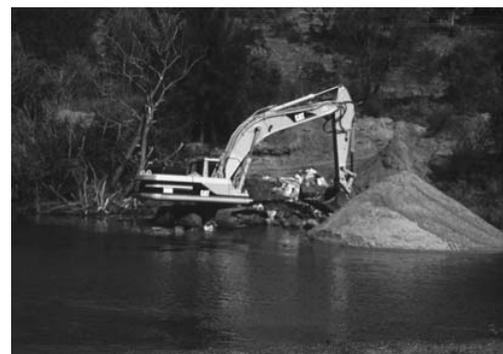
Figure 4. Construction of a deflector from the bank. Note the bank disturbance which has to be stabilised and revegetated.

Each deflector contains approximately 220 m<sup>3</sup> of rock. At each deflector site, the sand was excavated until a stable base was reached, before placing the rock to form the deflector. The first six deflectors were constructed from the bank, as high water levels precluded access from the river channel (Figure 4).

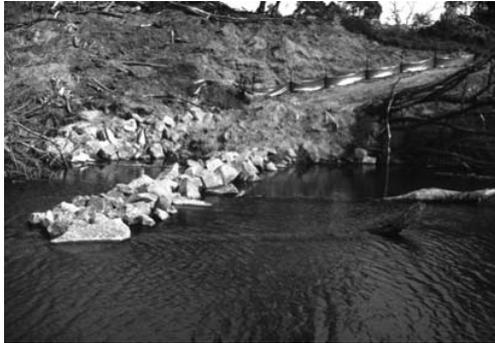
*Figure 5. Completed deflector showing logs projecting downstream. The commencement of rock armouring of the bank can be seen to the left of the deflector*

The banks immediately adjacent to the six deflectors that were not constructed from the river channel were rock armoured to prevent potential scouring and back-cutting (Figure 5). Bank armouring was not considered necessary for the nine deflectors where construction access was from the river channel, as there was minimal bank disturbance.

One or two hardwood logs have been incorporated into alternate deflectors to increase structural complexity. These logs are embedded into the deflectors and project approximately 6–8 metres from the downstream side (**Figure 5**). Ideally, complete trees would have been used in the deflector design. However, the lack of native riparian species in the study area meant that logs had to be transported by truck a considerable distance to the rehabilitation site, necessitating some ‘simplification’ of the logs, i.e. removal of heads and complex root wads.

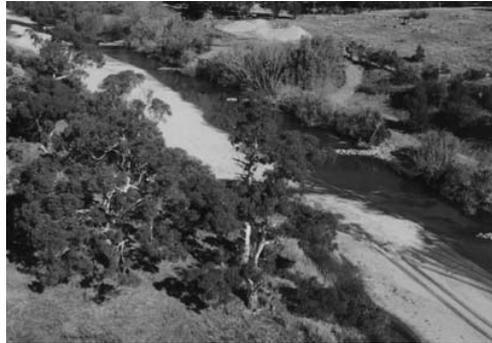
*Figure 6. Completed deflectors in the Murrumbidgee River. Note the remnant Eucalyptus viminalis on the near bank which were previously widespread throughout the riparian zone*

The construction of the 15 deflectors was completed in early May 2001 (**Figure 6**) and their efficacy in creating small-scale pools will not be able to be assessed until after the high winter flows have ceased.

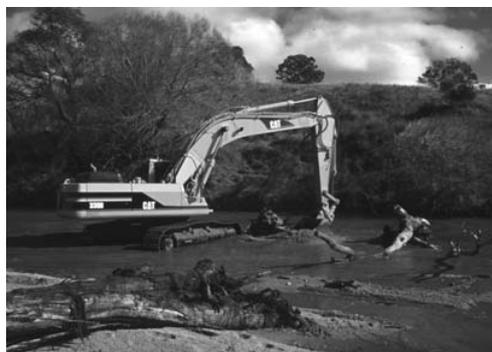
*Figure 7. Excavation of the habitat pool and placement of logs. Note the shallow water the excavator is standing in, indicative of the general depth of the river prior to rehabilitation*

The objective of the habitat pool was to create a major fish habitat pool in an area where deep pools no longer exist. The pool was 50 long x 15 m wide and was excavated down to stable substrate, giving a depth of 3–5 m.

Eight hardwood logs were incorporated into the pool to provide a snag pile, with the largest logs keyed into the sand on the inside of the bend to provide additional stability (**Figure 7**). It was originally proposed to key the logs into the bank on the outside of the bend, but the steep bank slope precluded the operation of heavy excavation machinery, and so the habitat pool was excavated from within the river channel.

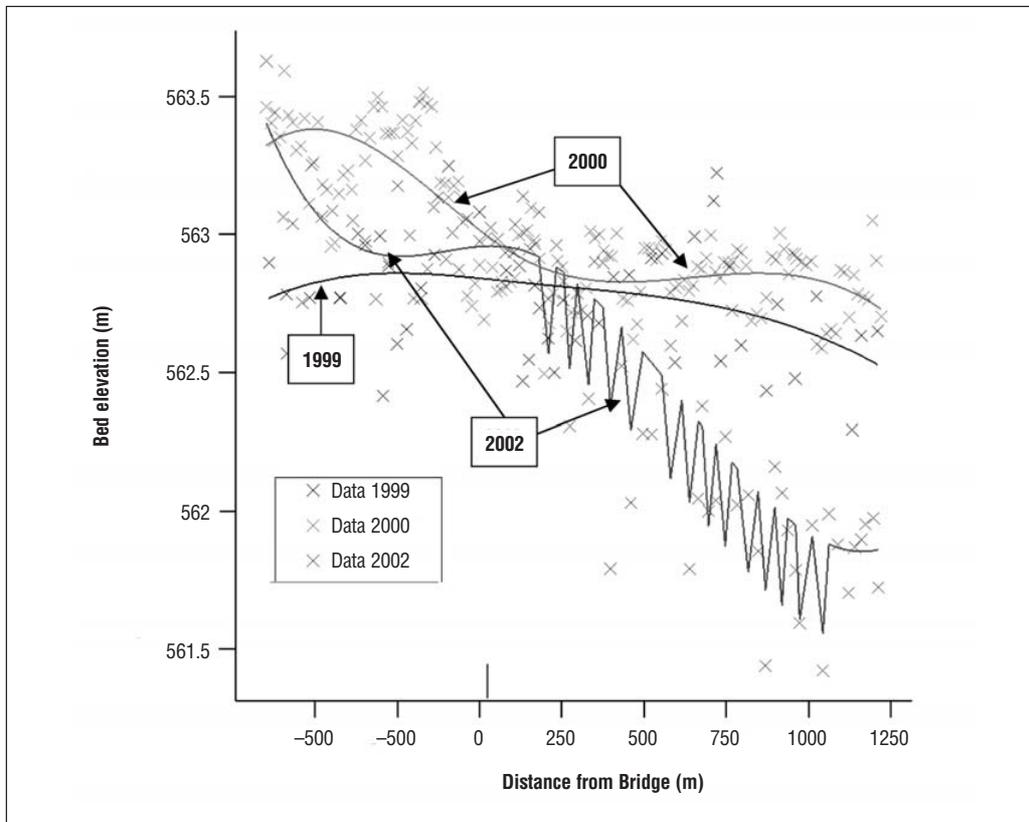
Figure 8. Graphs showing change in bed elevation with distance in the Murrumbidgee River in 1999 & 2000 (pre in-stream works) and 2002 (post in-stream works). The lines represent smoothed functions fitted to the raw data, and allowing it to change from year to year. The statistical analysis takes account of the very strong correlation of one measurement to another. An average effect of the deflectors has been incorporated into the 2002 fitted function. The bridge is at distance 0, with negative distances indicating upstream of the bridge and positive distances downstream of the bridge

Prior to the commencement of in-stream works the mean elevation (metres above sea level)(ASL) of the thalweg (the thread of deepest water) in the stream section upstream of the deflectors (between 647 m upstream of bridge and 100 m downstream of bridge) was 563.22 m. The same parameter was 563.01 m ASL in 2002 after the deflectors were installed and operational for 12 months, a difference of 0.21 m between sampling occasions. By contrast, the mean elevation of the thalweg in the stream length affected by the deflectors (from 150 m to 1060 m downstream of bridge) went from 562.86 m ASL in 2000 prior to in-stream works, to 562.23 m ASL after the deflectors were installed and operational for 12 months, a difference of 0.63 m.

Whilst these differences in bed-lowering above and below the in-stream works appear slight, graphs of the change in the bed elevation clearly demonstrate the effects of the deflectors in lowering the bed of the river (**Figure 8**). Figure 8 shows the non-random nature of the change in bed elevation, with a significantly different relationship between bed elevation and distance since the construction of the deflectors.

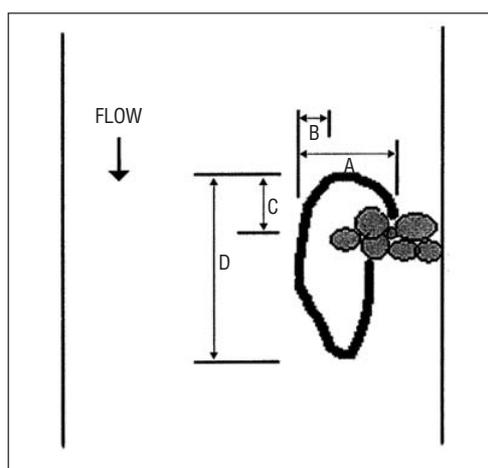
Figure 9. Measurements taken of scour pools formed by deflectors

Preliminary visual monitoring during construction indicated that water velocity around the toe of the deflectors had increased almost immediately and active sand scouring could be observed. A series of measurements of the scour pools were taken in March 2002, approximately 10 months after the completion of the in-stream works program, and again in March 2003, with the following measurements recorded (Figure 9):

- Maximum depth of the scour pool,
- [A] width of scour pool on upstream side of deflector,
- [B] distance from edge of scour pool to tip of deflector,
- [C] upstream extent of scour pool from the midpoint of the tip of deflector, and
- [D] total length of scour pool.

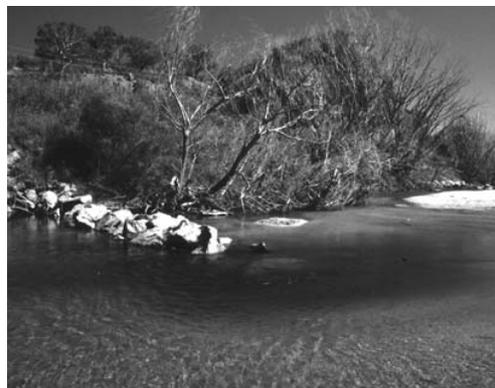
Figure 10. The scour pool at the end of deflector No. 3. Note the sand depositing downstream of the scour pool

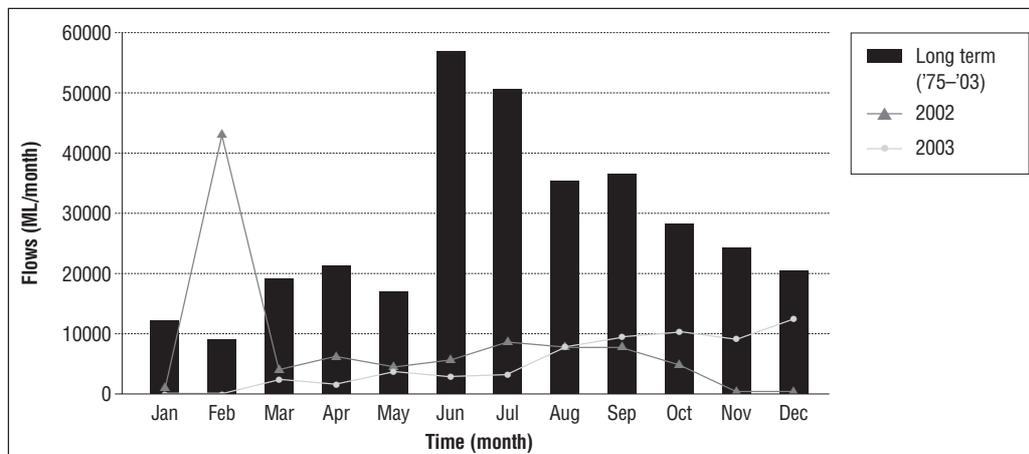
Figure 11. Long-term average monthly flow (histogram) and monthly flows (lines) at Lobbs Hole on the Murrumbidgee River (upstream of Tharwa) in 2002 and 2003 following completion of in-stream works

It must be remembered that streamflows in the Murrumbidgee River following the completion of the in-stream works were extremely low, as a result of the worst drought in 100 years (Figure 11). It must also be realised that following the severe Canberra bushfires of January 2003, and subsequent extensive erosion from burnt areas following the fires, coupled with the low drought flows, the ability of the deflectors to create and maintain scour pools under such extreme conditions is remarkable, and that in normal or average years, the depth and extent of the scour pools may have been considerably greater.

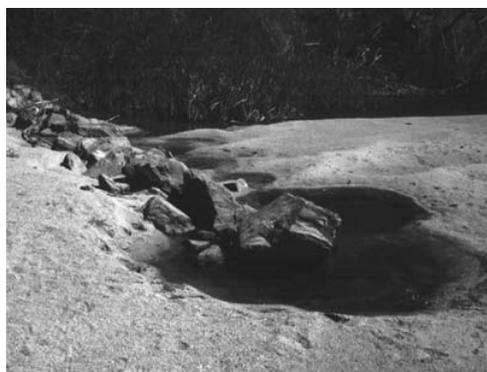
Figure 12. Deflector No. 10 which has been swamped by sand

Four of the deflectors (Nos. 1, 7, 10 & 13) have not functioned very well, with only small, shallow scour pools produced. Deflectors 1, 7 and 10 are all at the upstream extremities of deflector groups, and so are sensitive to minor shifts in the thalweg position. Deflector 10 has been totally swamped by sand and is now isolated from the main river channel (Figure 12), whilst deflector 13 has a structural defect in the middle, which is allowing water to flow through the deflector rather than around it. The deflectors at the upstream end of a group seem to be the least effective, as a minor change in the position of the thalweg can effectively move the flow away from the deflector and leave it prone to being swamped by sand.

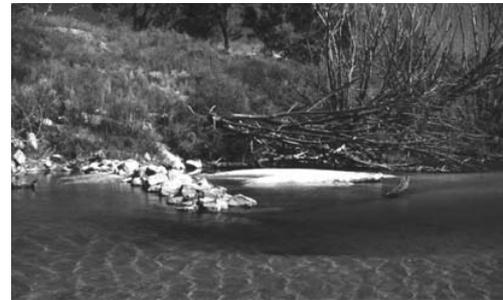
Figure 13. The scour pool of deflector No. 12. Note the snag near the tip of the deflector is still within the pool, whilst the snag in the middle of the deflector has been buried by sand. (see Figure 6 for how the deflector looked immediately after construction)
